ENSURE THE STRICT APPLICATION OF PROCEDURES

This event occurred during a night transit on the way back with 12 passengers onboard. The Surfer was coming back to base after a long journey and several interfield transfers with no break. Several gaps were identified during this incident: the passage plan was not respected, the night sailing speed was exceeded (15 knots max by BMO standards) and the watchkeeping was not adapted. The AB was resting on the folding seat next to the pilot, from where he could not ensure his watch nor notice if the pilot was dozing. Approaching dangerously near the shore, the vessel finally ran aground on a beach.

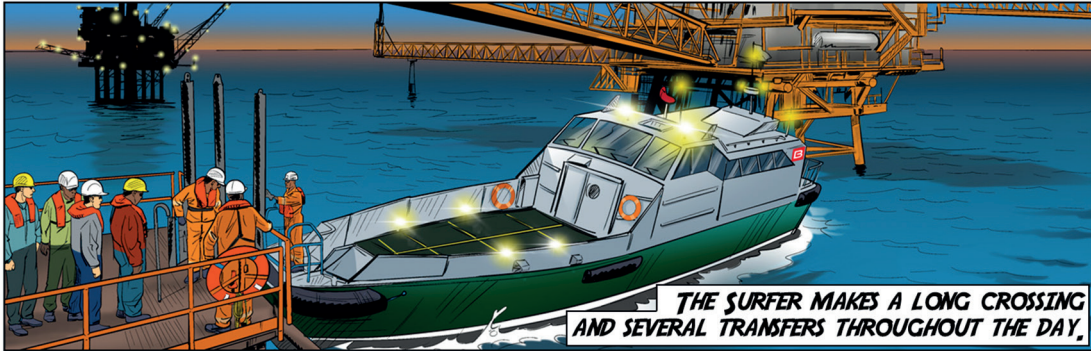
THE SURFER MAKES A LONG CROSSING AND SEVERAL TRANSFERS THROUGHOUT THE DAY.

- Adapt the sailing speed to environmental conditions (15 knots max at night).
- Maintain an appropriate visual and auditory watch at all times.
- Properly set up the navigation equipment and respect the passage plan.
- Ensure with the client that the Surfer's program has been planned before every departure.
- Ensure the crew's rest periods are respected, as well as working hours, with records and monitoring by Crew and Shore Operations team.

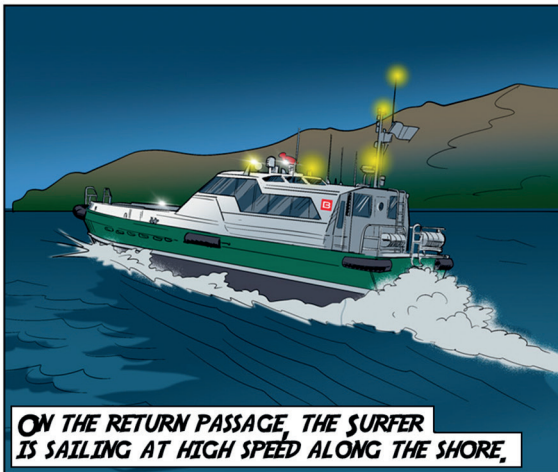
ON THE RETURN PASSAGE, THE SURFER IS SAILING AT HIGH SPEED ALONG THE SHORE.

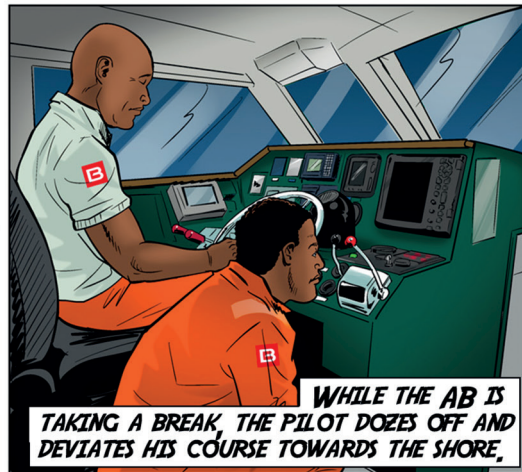
WHILE THE AB IS TAKING A BREAK, THE PILOT DOZES OFF AND DEVIATES HIS COURSE TOWARDS THE SHORE.

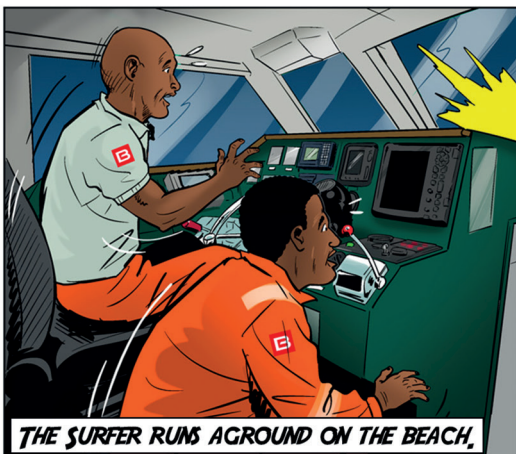
THE SURFER RUNS AGROUND ON THE BEACH.

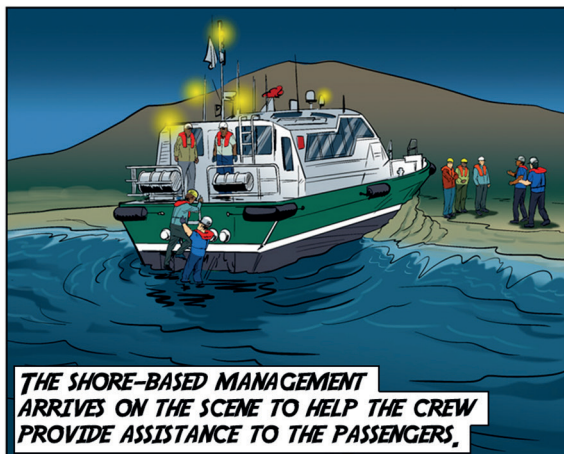
THE SHORE-BASED MANAGEMENT ARRIVES ON THE SCENE TO HELP THE CREW PROVIDE ASSISTANCE TO THE PASSENGERS.
